5 Name Of Dam: DAM ON THE HEADWATERS OF SQUALL CREEK  
3 Location: PATRICK COUNTY, VIRGINIA  
8 Inventory Number: VA 14104

# PHASE I INSPECTION REPORT NATIONAL DAM SAFETY PROGRAM

FEBRUARY 1978

6 National Dam Safety Program. Dam on the Headwaters of Squall Creek (VA-14104), Roanoke River Basin, Patrick County, Virginia. Phase I Inspection Report.

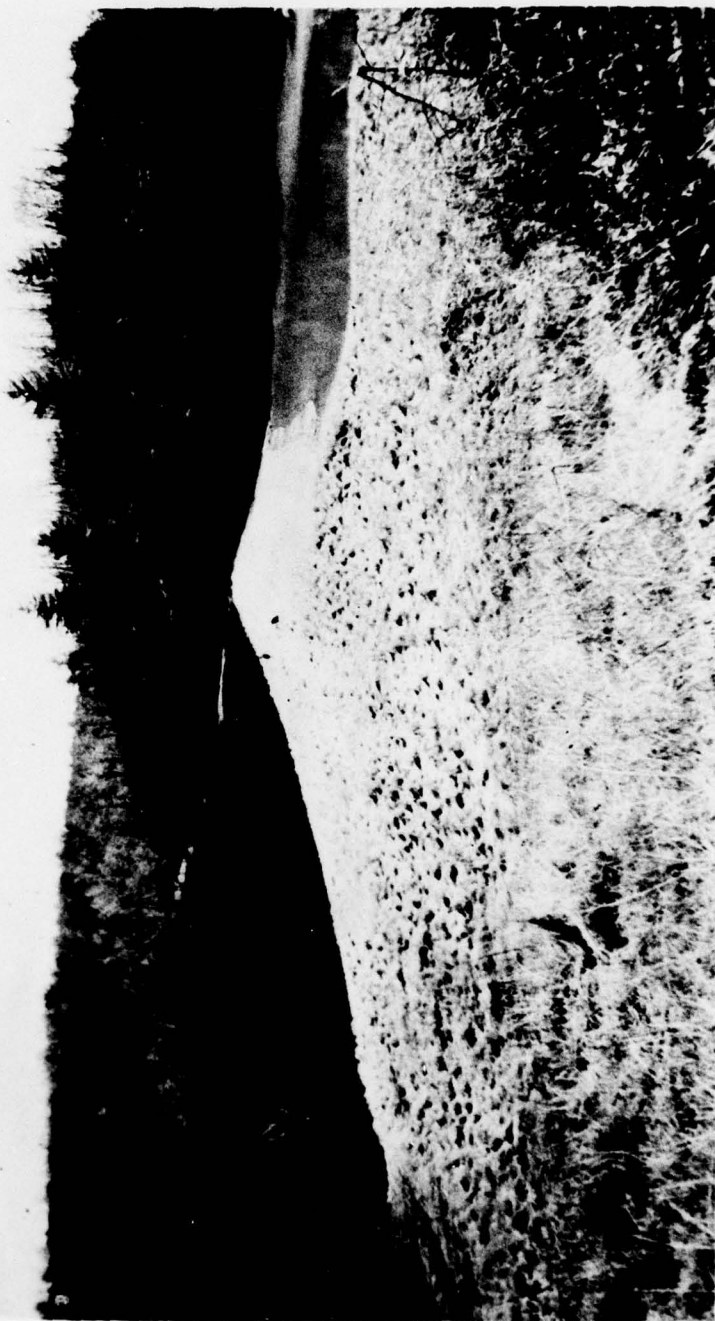
DAM ON THE HEADWATERS OF SQUALL CREEK - OVERVIEW OF DAM FROM LEFT ABUTMENT

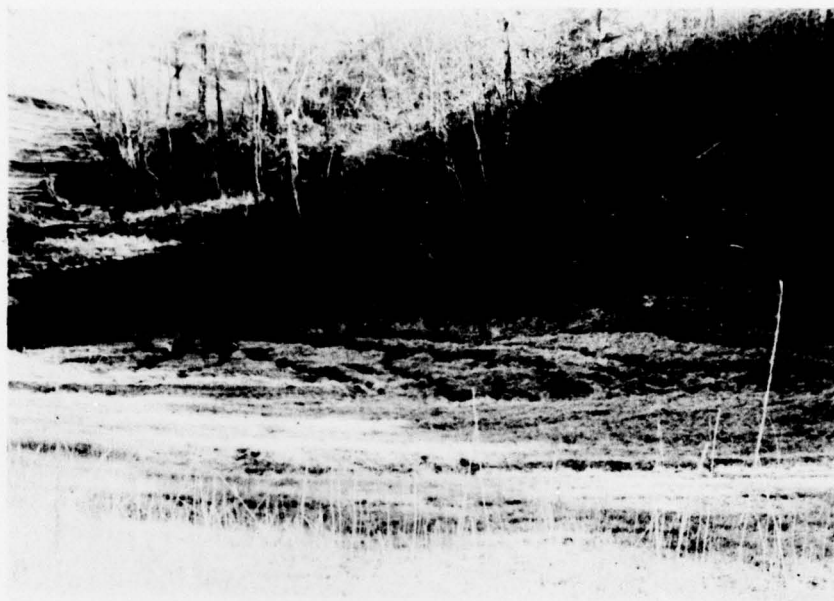
3.1.2.1 Embankment. The earth fill dam was constructed from local residual material which had been weathered from underlying schist or phyllite bedrock. The only sign of distress on the embankment was the severe erosion on the downstream slope. The erosion gullies ranging in depth from 6 inches to 3 feet were more pronounced near the abutment contacts where surface runoff was being channeled from the abutment slopes. Vegetative cover ranged from adequate near the dam crest to nonexistent in the areas of severe erosion. The visible portion of the upstream slope was 4h to 1v.

VIEW LOOKING DOWNSTREAM FROM CREST OF DAM - NOTE EROSION  
ON THE DOWNSTREAM SLOPE

7.2 Remedial Measure. The severe erosion problem should be addressed immediately to prevent further slope deterioration. After filling and seeding the existing gullies, measures should be taken to prevent erosion while the vegetative cover is being established. In an effort to prevent further erosion, surface runoff from the adjacent abutments should be redirected away from the embankment slopes.

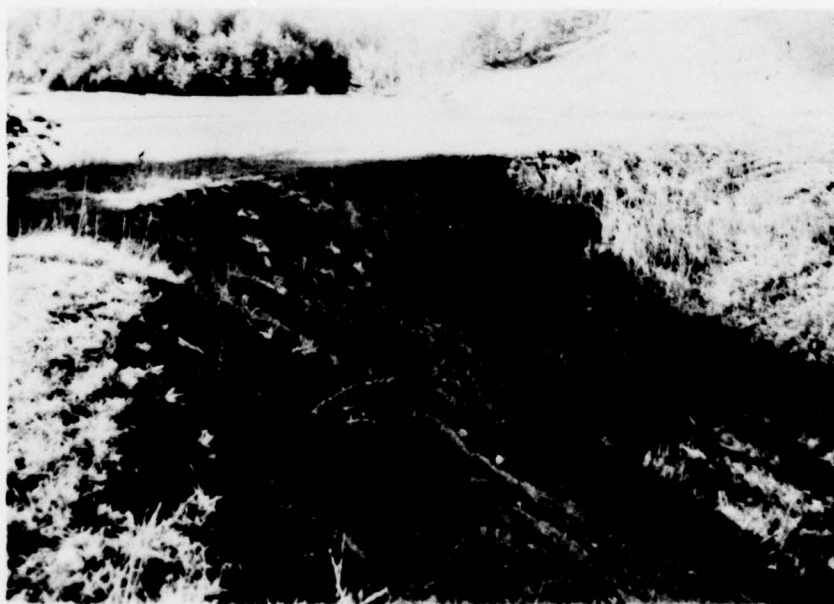
VISUAL EXAMINATION OF	OBSERVATIONS	REMARKS OR RECOMMENDATIONS
R. T. Abutment:	An unimproved access road slopes down along the right abutment to the dam crest. This road intercepts runoff from the Rt. abutment slopes and diverts it down the D/S embankment slope, thus contributing to the severe erosion. Also, the Rt. abutment has been cut to a lv. to lh. slope and adjacent to the embankment contact.	The runoff intercepted by the road should be diverted away from the embankment slopes or channelled into a paved ditch.
JUNCTION OF EMBANKMENT AND ABUTMENT, SPILLWAY AND DAM	Severe erosion is prominent along the contact between the Rt. abutment and the embankment as discussed above. Minor erosion was noted at the contact between the Lt. abutment and the embankment. The spillway (emergency) is cut into the undisturbed left abutment approximately 250' north of the embankment.	Runoff from the abutment slopes should be diverted away from the embankment slopes. The existing erosion should be arrested by a vegetative cover.

j. The access road on the south abutment slopes downward toward the dam. The road is graded in a manner which allows runoff, intercepted by the road, to run along the interface between the embankment fill and natural ground of the south abutment. This condition undoubtedly contributed to the formation of the deep erosion gullies in the fill adjacent to the south abutment.

VIEW LOOKING NW FROM RIGHT ABUTMENT ACROSS DAM CREST - NOTE  
EROSION AT EMBANKMENT - ABUTMENT CONTACT

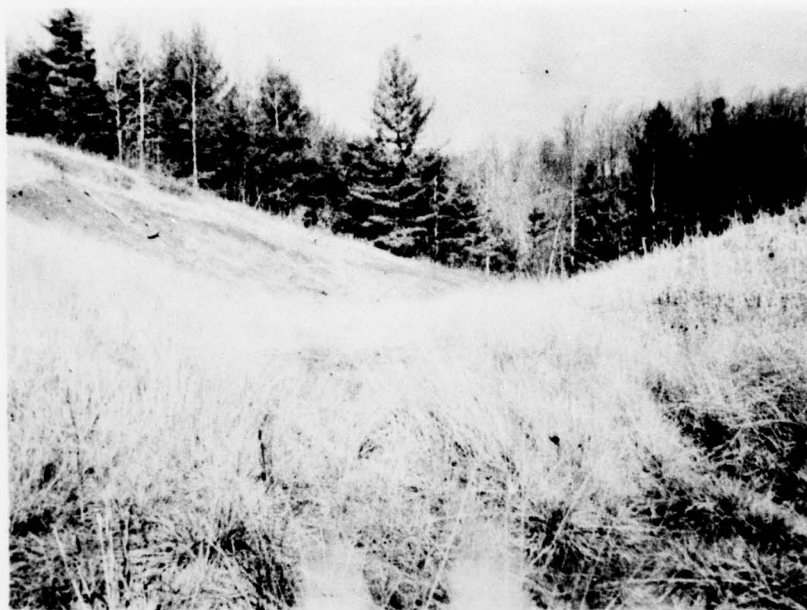
APPROACH CHANNEL There is very little vegetative cover within the spillway channel. Some rock outcrops are present.

The emergency spillway is cut into the left abutment. The base of the channel ranges in width from 20 to 26 feet. The side slopes are erratic with slopes ranging from 1v to 2h to 1v to 1h.

VIEW OF SPILLWAY - LOOKING DOWNSTREAM FROM UPSTREAM ENTRANCE

The crest of the spillway is approximately 4 feet below the crest of the dam. It is recommended that a vegetative cover be established in the spillway to minimize erosion.

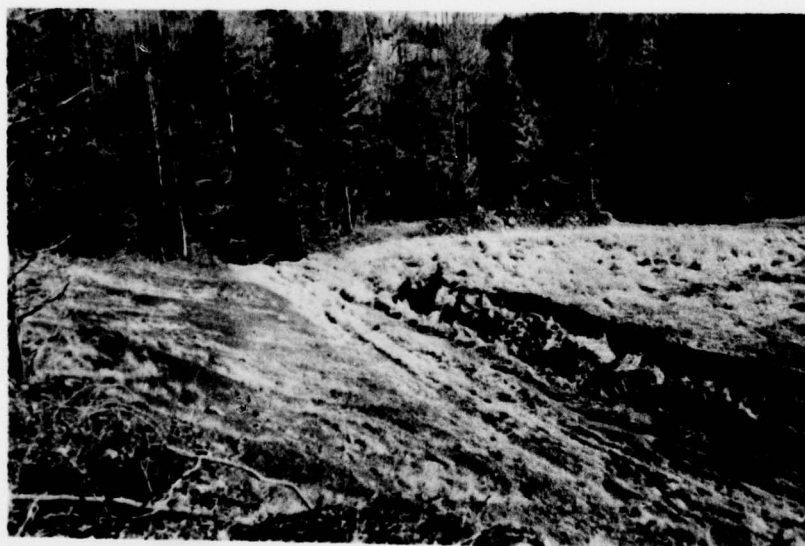
The approach channel is approximately 300' long and drops approximately 5.5' from influent to discharge. The spillway discharges into Squalls Creek down a slope of 1v to 1h.

VIEW OF DOWNSTREAM END OF SPILLWAY LOOKING EAST

The spillway discharges into Squalls Creek proper, thereby, minimizing the effect on the dam. The sides of the channel near the discharge point should be built up to prevent water from spilling over onto the left abutment/embankment contact.
